INVESTIGATION OF THE NORTHWEST AREA OF
ROCKY MOUNTAIN ARSENAL

GEOHYDROLOGY DIVISION
CONTAMINATION CONTROL DIRECTORATE

NOV 78

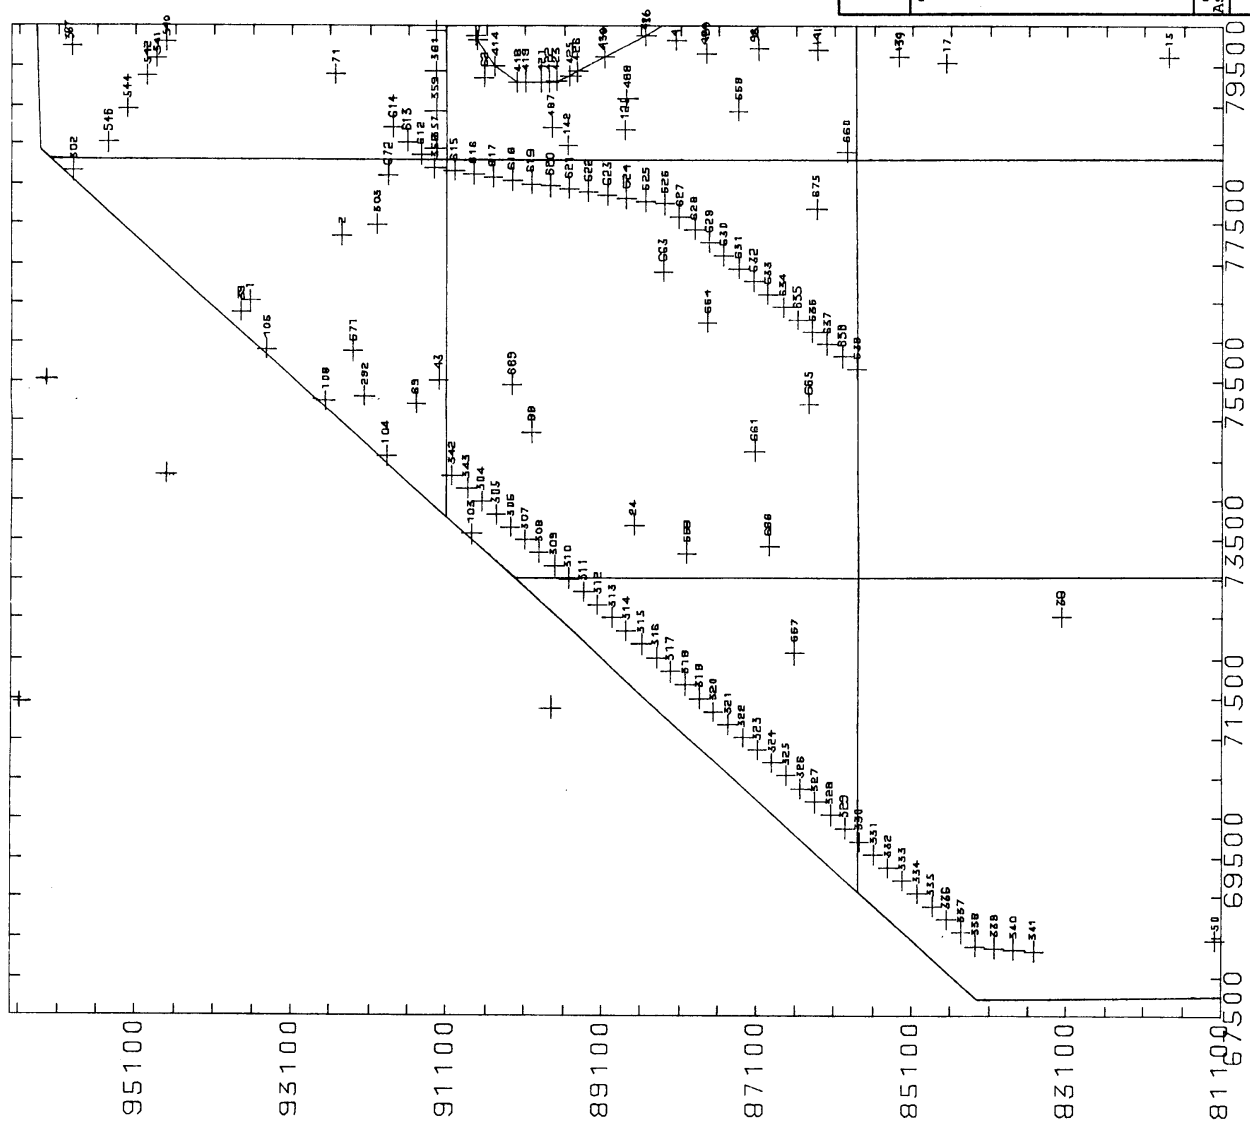
UNITED STATES ARMY ROCKY MOUNTAIN ARSENAL COMMERCE CITY, COLORADO		GEOGRAPHIC BRANCH	
CONTAMINATION MIGRATION DIV.		GROUNDWATER CONTAMINATION MIGRATION FOR THE NORTHWEST AREA OF RMA WELL LOCATION MAP	
SCALE: AS SHOWN	APPROVED	DATE Oct 78	FIGURE 2

(3) The investigation in the report area was started in 1976 and continued into 1978. Figure 2 shows the locations of the monitoring wells used to evaluate water quality. Figure 3 shows the locations of borings that were used to determine the geologic setting.

(3) Water samples (see Table 1 and Figure 2) to evaluate aquifer condition were collected and analyzed by MALD following the previously used and approved procedures. Wells were sampled at least once. Those wells which are part of the 3600 monitoring program had been sampled many times over an extended time. A variety of constituents were investigated. In many cases, only a portion of these constituents were investigated in a particular sample. The following parameters were investigated: DIMP (diisopropylmethyl phosphonate), DCPD (dicyclopentadiene), DBCP (dibromochloropropane, Nemagon), Sodium, Chloride, Sulfate, Nitrate, Fluoride, Oxathiane, Dithiane, Parachlorophenyl methyl sulfide, Chlorophenyl methyl sulfoxide and sulfone, Aldrin, Dieldrin, Isodrin, DDE, DDT, and Endrin.

(1) The quality of the groundwater was assessed from water samples collected within the study area. The northwest area of the Arsenal included wells from Sections 22, 27, and 33, parts of Sections 23, 26, and 35, and off-post sites (Table 1, Figure 2).

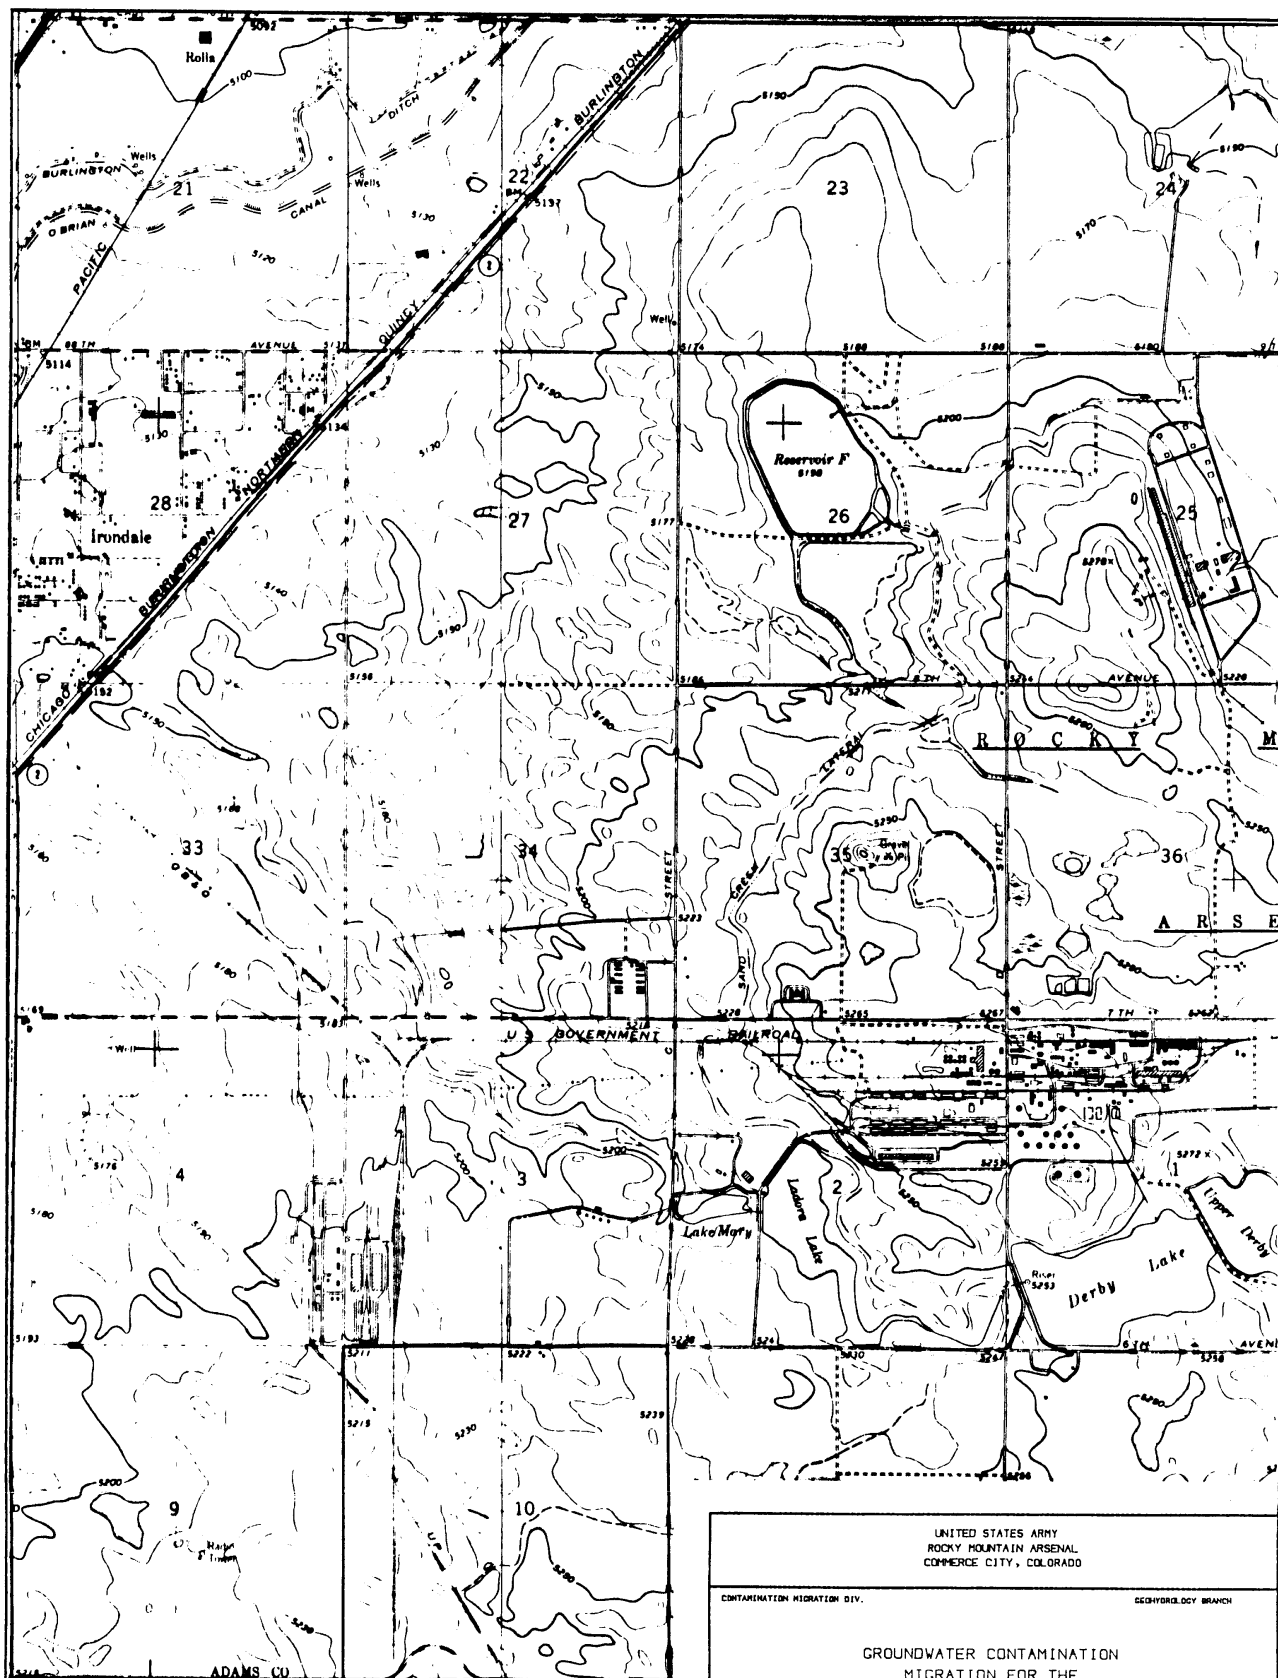
UNITED STATES ARMY ROCKY MOUNTAIN ARSENAL COMMERCE CITY, COLORADO		
CONTAMINATION MIGRATION DIV.		GEOHYDROLOGY BRANCH
GROUNDWATER CONTAMINATION MIGRATION FOR THE NORTHWEST AREA OF RMA GROUND ELEVATION MAP		
SCALE: As shown	APPROVED	DATE Oct 78
FIGURE 4

(4) The formation outcrops at three gravel-capped pediments on the Arsenal. These outcrops are located west and north of Basin A and are characterized by the prominent topographic highs (Figure 4).

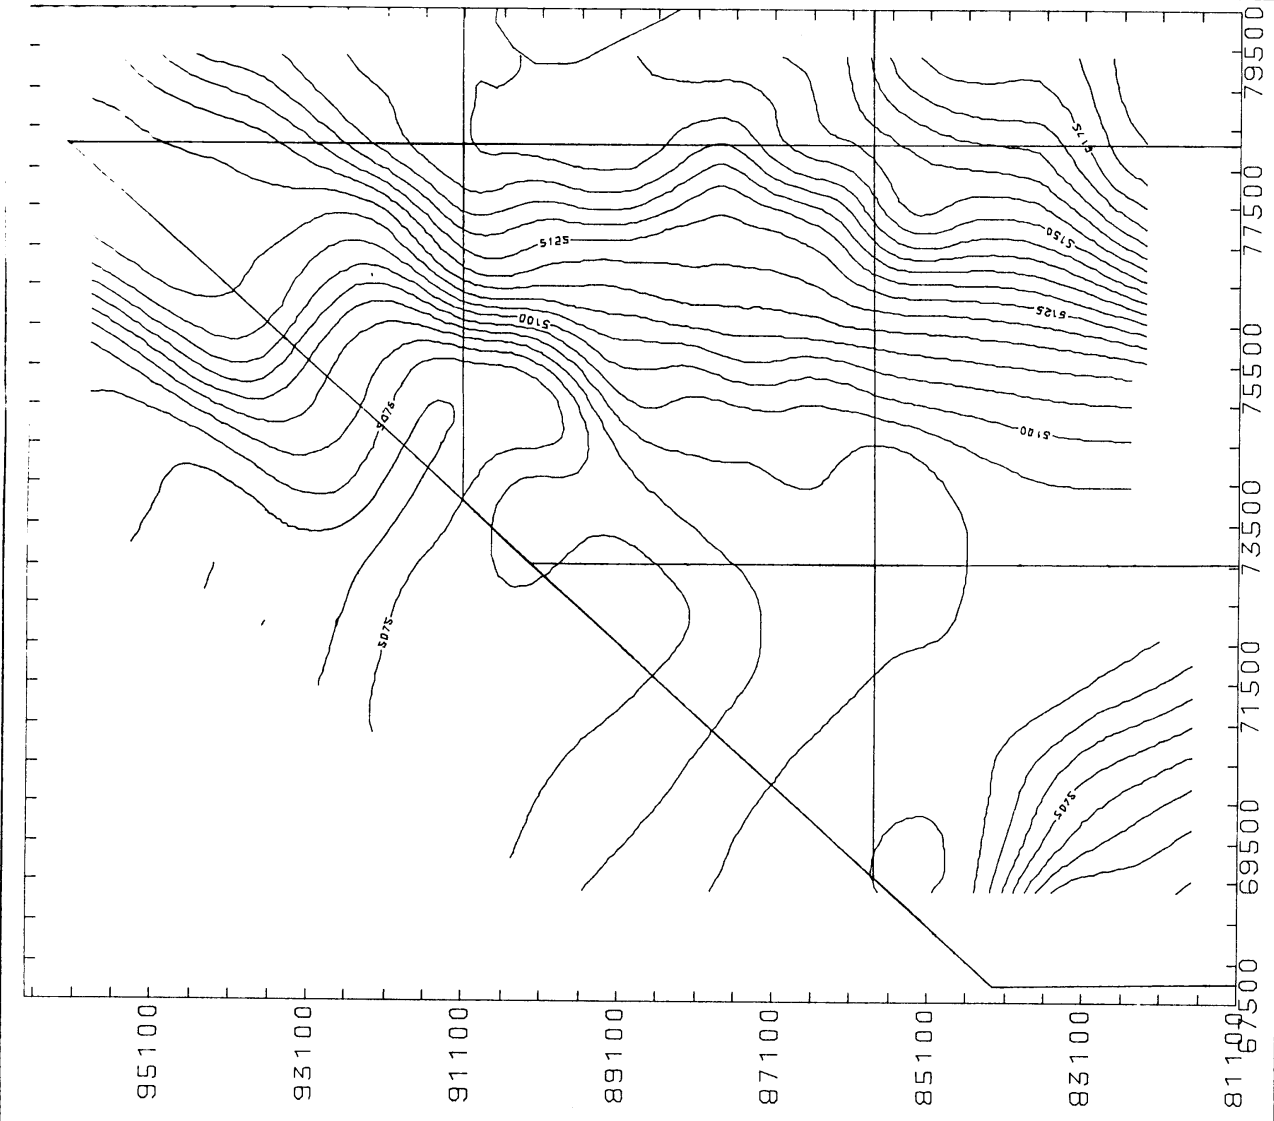
UNITED STATES ARMY ROCKY MOUNTAIN ARSENAL COMBINE CITY, COLORADO		DATE Oct 78	
CONTAMINATION MIGRATION DIV		APPROVED	
GROUNDWATER CONTAMINATION MIGRATION FOR THE NORTHWEST AREA OF RMA BEDROCK ELEVATION MAP		FIGURE 5	
Contour Interval 5 Ft.		Contour Interval 5 Ft.

(7) The field drilling operation identified the bedrock contact at 257 locations in the study area. From this data, both a bedrock contour map and transect map were constructed (Figures 5 and 6). The bedrock contours indicate that the Denver-Arapahoe unit slopes generally from southeast to northwest. In detail, the bedrock surface is irregular with numerous channels and gullies apparent. The study area overlies two major channels. The channel which has the most influence in the hydrology of the study area lies on the eastern edge of Sections 34, 27, and 22. The second channel is located on the southwestern

corner of the study area. Both channels are characterized by the close contour intervals on the bedrock contour map, Figure 5. The small irregularities of the bedrock surface are very likely due to the erosional characteristic of the material. The erosional forces moved the sand and silty sand bedrock materials easier than the clay and silty clay materials. With the formation of interbedded layers of these materials, the potential for an irregular erosional surface to be developed exists. The patterns of the erosional forces are also responsible for the irregular bedrock surface

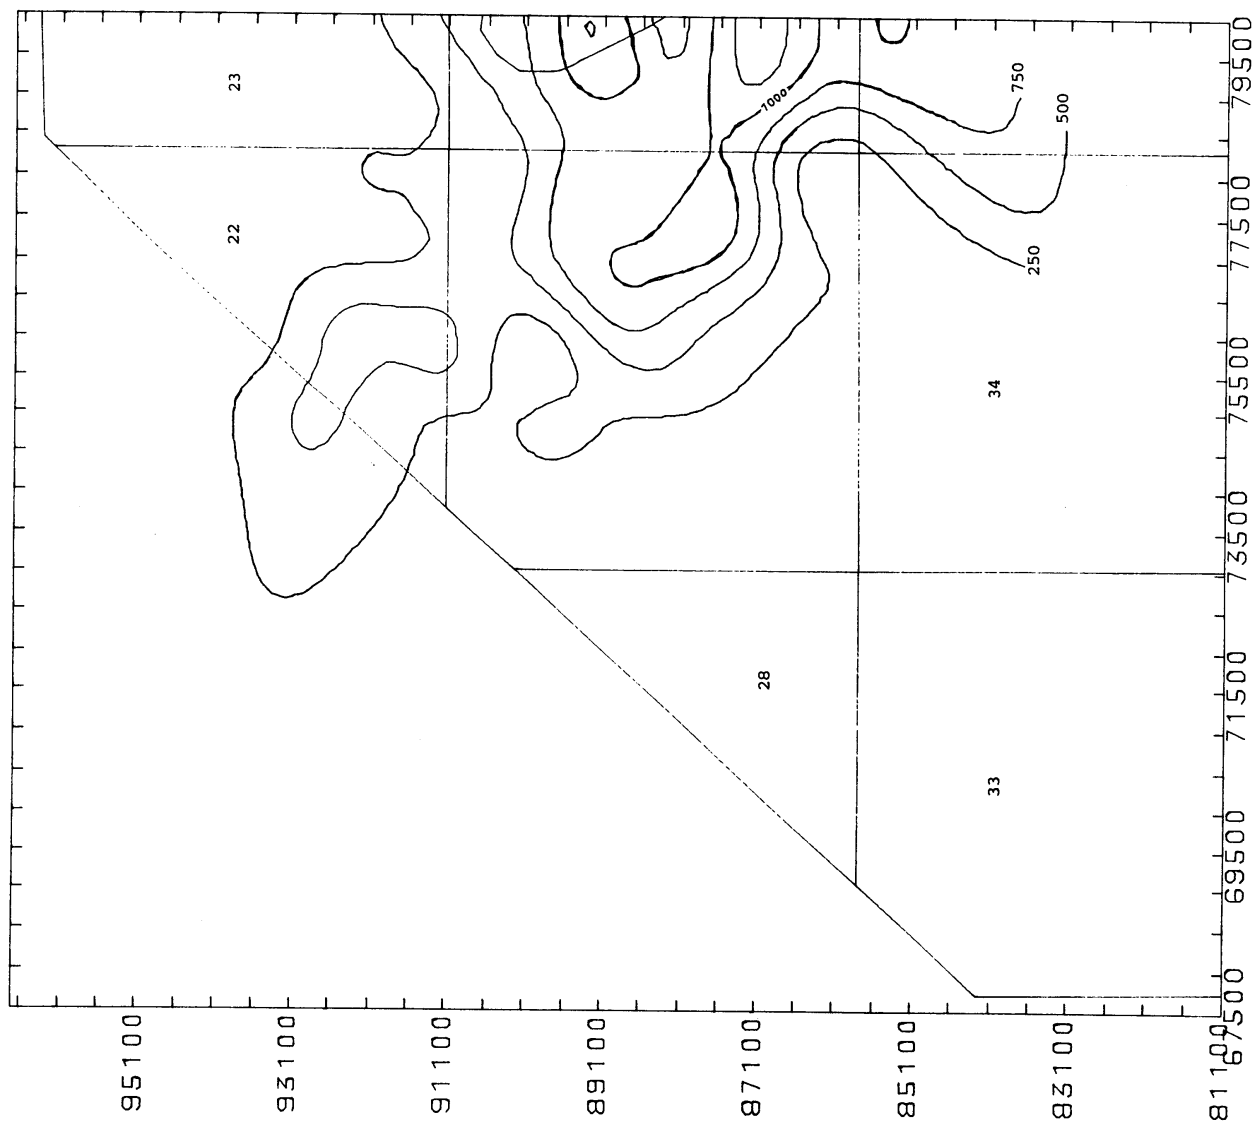
FIGURE 37. DISTRIBUTION OF CHLORIDE
IN THE NORTHWEST AREA OF RMA.

(8) Table 2 lists the data for the remaining constituents. Figures 37, 38, and 39 depict the distribution of Sodium, Chloride, and Sulfate in the study area. As the objective of this paper was to provide information about pollutants, these remaining parameters are not individually discussed.
